## Case Study - How we saved a Process Plant from break-down

We were appointed to carry out the routine maintenance and testing of the Switchgears, Relays, CTs & PTs in one of the Cement Plants in India, having its own Power Plant. This Power Plant combined with Grid Supply catered to the plant load.

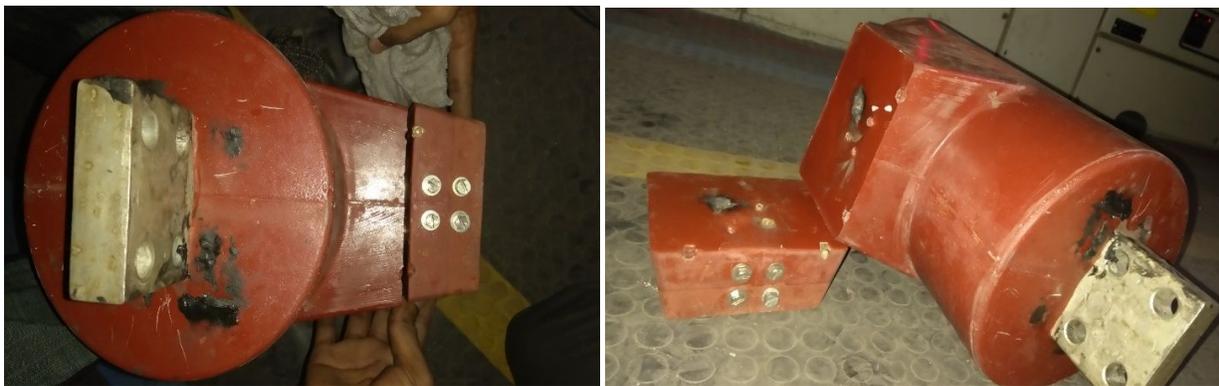
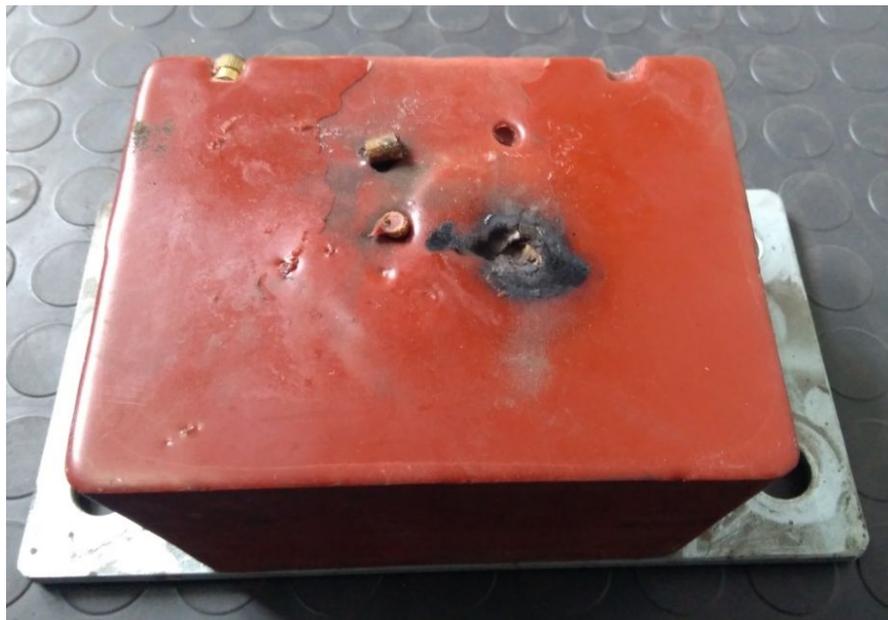
During this Testing, Protection Core (5P10) of a CT was having a very high secondary resistance, the instrument displayed “Secondary Winding resistance is too high”. CT Analyzer determines winding resistance by applying DC current into Secondary winding and checks voltage drop across Secondary Terminals.

This higher value of CT Secondary Winding indicates that CT could be open and may mal-operate the relay in case of various loading scenarios. We enquired about any such incident in the past, but the history was clean, there was no such tripping and plant operated normally.

***Damaged CT Found in Panel***

As we can see from the above images, Secondary Winding with its internal connection is cracked and barely hanging, a little nudge and it separated! We can also observe hotspots/carbonisation all around.

- As it can be seen from the above image, there is a CT base-plate, and CTs are usually mounted in Panel by base-plates, and usually, upside down. Main Primary Bus-bar of CT is connected with main Power Bus-bar of panel.
- Here, 2 opposite forces caused this failure :
  1. Upward force by Fixed Base-plate
  2. Downward force by Main Power Bus-bars

CT was in operation under stressed condition for very long time. Over a period, Secondary Winding started getting disconnected, and during testing, it showed higher resistance.
