Case Study - How we saved a Process Plant from break-down

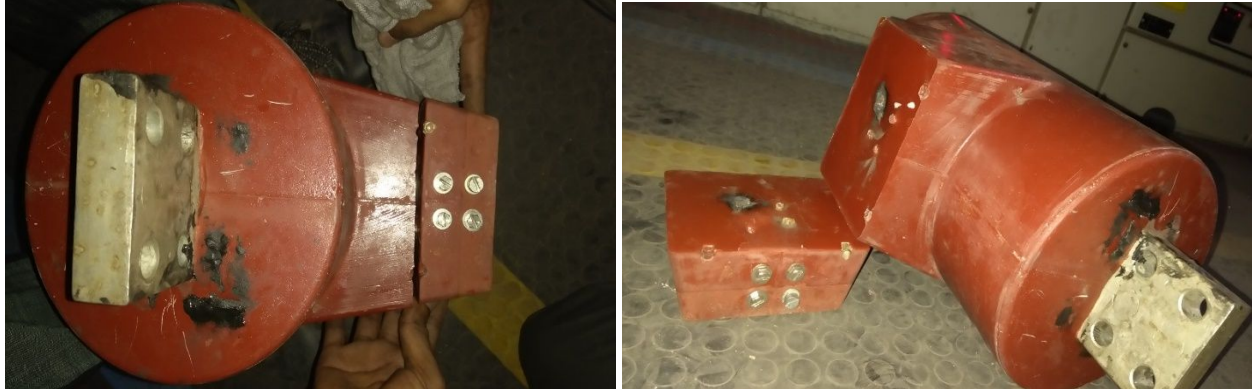
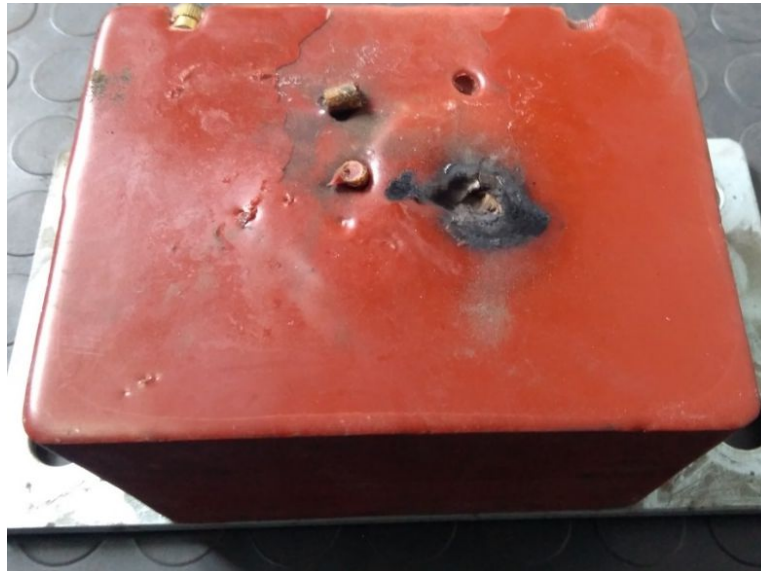
Damaged CT Found in Panel

As we can see from the above images, Secondary Winding with its internal connection is cracked and barely hanging, a little nudge and it separated! We can also observe hotspots/carbonisation all around.

As it can be seen from the above image, there is a CT base-plate, and CTs are usually mounted in Panel by base-plates, and usually, upside down. Main Primary Bus-bar of CT is connected with main Power Bus-bar of panel.

- Here, 2 opposite forces caused this failure :
 1. Upward force by Fixed Base-plate
 2. Downward force by Main Power Bus-bars

CT was in operation under stressed condition for very long time. Over a period, Secondary Winding started getting disconnected, and during testing, it showed higher resistance.

- Noteworthy here is, despite this damage, CT might have been transforming the currents faithfully, as the CT type was a moulded cast resin (a rubbery fibre like material), the leads somehow remained connected. So, when there was primary current, secondary current completed the path by puncturing nearby insulation, this generated high voltages and thus the arcing spots - as can be seen in the images.

- As we've seen that this CT might have transformed the Currents faithfully or with little error. There was not enough unbalance current to trip the Relay, so, the Feeder did not trip, but it was just on the verge of failure when this was detected.
