Case Study - How Spare Motor kept in store can betray your hope of lesser Breakdown

In a process plant, there were four identical **132 kW, 415 Volt, 955 RPM** process fans, each powering a critical process unit. Since there were no standby fans, any motor failure could lead to significant production losses of 60-70%.

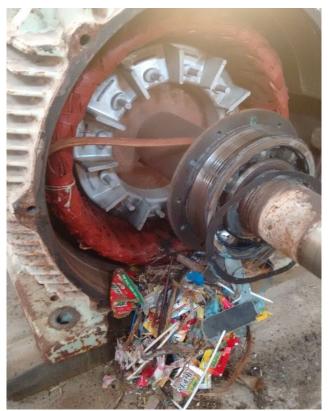
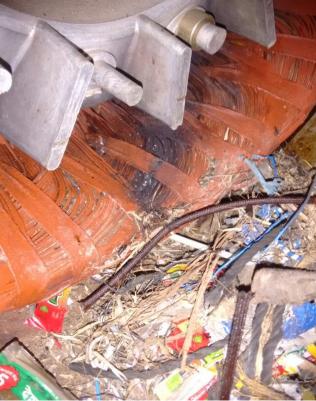
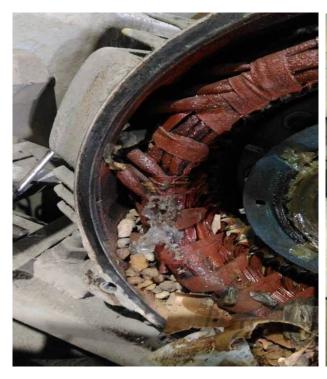
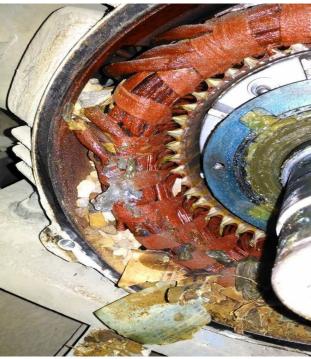
See the photos below

Now the time was for inspection of what happened to the spare motor who's all parameters like resistance, inductance and insulation resistance were ok. When the completely dismantled the motor removing the rotor from stator, they couldn't believe it.

OMG where all these come from and that too inside the motor?

There was plastic wrappers (of Vimal, Rajshree, Panparag, etc) and a **dead small mouse** too. But still how it get inside and that too between the rotor and stator?

They went to the store again to check. Around 100+ spare Motor was kept in big store room. After seeing 3 motors we got our answers. The motor was packed but the sealing of cable gantry in the terminal box of some of the motors was not available. Now the maintenance team got their answers (the mouse went between stator and rotor through terminal box and must have taken some foreign material with it).

The maintenance Team themselves invited a very hectic work for the next 15 days to check all such motors by opening both end covers and looking at the condition of stator and rotor to prevent such breakdown / downtime.

First, They covered all such open sealing in the Motor terminal box and then complete motor TB was covered with polythene. Also, they asked store people to keep and spread Mouse / Rodent repellent across store where Spare motors was kept.

They got around 10 more motors which have become the House of Mouse, problem was rectified, overhauling were done of those motors and trial taken of each motor for a round 10-12 hours in the workshop. Still wishing such motors don't betray us again.
