Case Study - How we solved an Earth-fault (mal)Tripping that was causing tripping of complete plant

Background

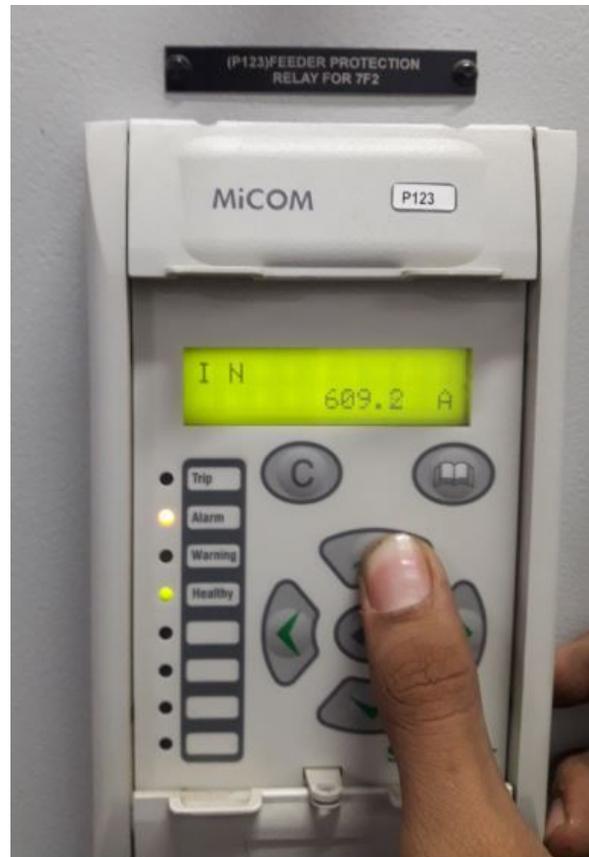
Image 1 : Actual Relay Measurement

As, it can be seen (*Image 1*) on the relay, Current in the Neutral is around 610 A. Earth Fault Pick-up was set at 400 A in the relay. Hence, relay kept operating when it sensed higher current. Phase CTs were having a ratio of 4000/1 A and the Earth Fault element was set at 400 A, i.e., 10 %.

- We found that R and B Phase CTs were having minor errors, but Y phase CT had a ratio error of 50 % at rated burden. It means, CT will act as it is having a ratio of 4000/0.5 A instead of 4000/1 A. Phase angle error was also found to be -1574.06 min.
- Due to high errors (Magnitude and Phase angle) of Y Phase CT, relay mal-operated in Earth Fault element.
- The faulty CT was replaced with a new CT after proper testing and wiring, the Transformer was switched on and re-commissioned with loading.
